**IEPA - DIVISION OF WATER POLLUTION CONTROL
DIGITAL PHOTO REPORT**

Date: 5-23-13	Site Name: James McCune
Photo By: Lee Heeren	 
County: Bureau	
Comments: A view of the M-6 swine facility located southeast of the <small>Exemption 6 and Exemption 7(C)</small> address for James McCune on 1945 N Avenue. This 3600-hog capacity building has 8 ft deep manure pits and tunnel ventilation. View is southeast.	
Photo #: 1	
Photo Title: 052313_JamesMcCune_LH(1)

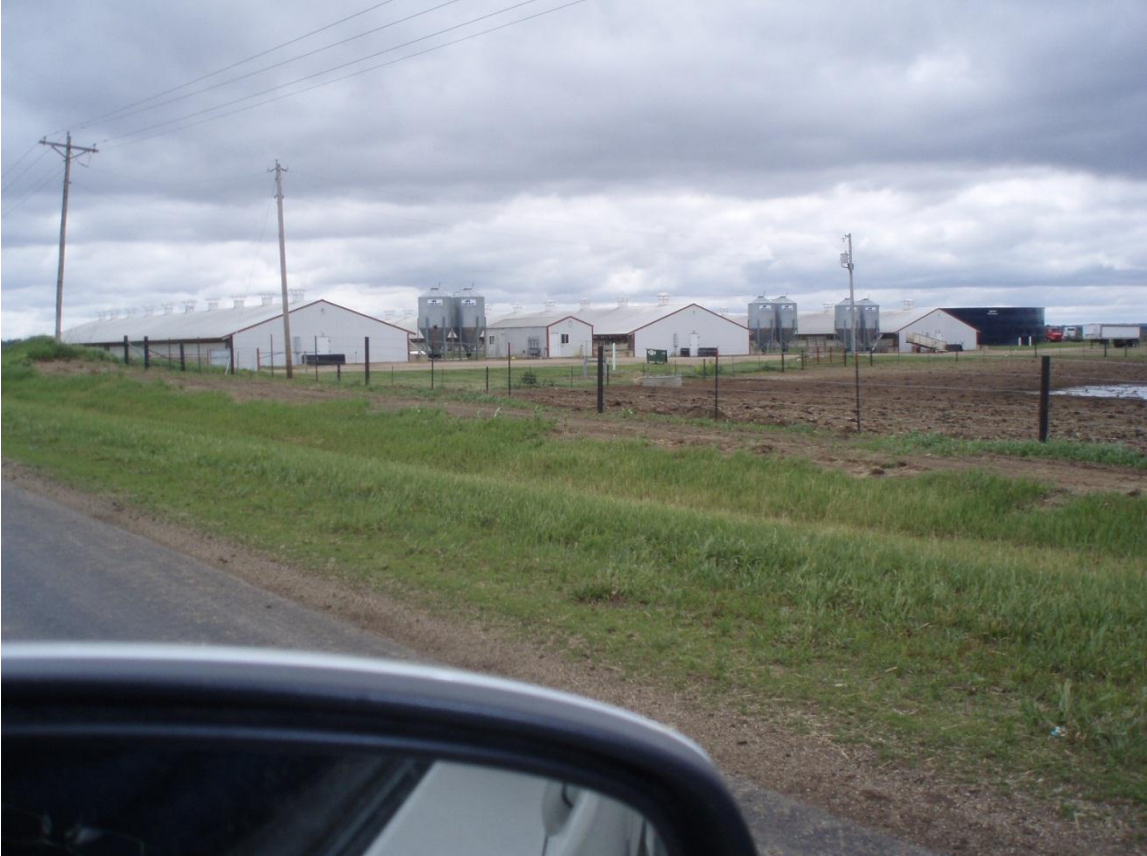
County: Bureau	
Comments: A view of the M-1 swine facility located approx. [redacted] on 1945 N Avenue. There are three 1100-hog capacity barns having a 2 ft partial manure pit that contains a scraper system that transfers the manure into a reception pit and ultimately into an adjacent 1.6 MG Slurrystore. These barns are older, naturally ventilated barns. View is northwest.	
Photo #: 3	
Photo Title: 052313_JamesMcCune_LH(3)

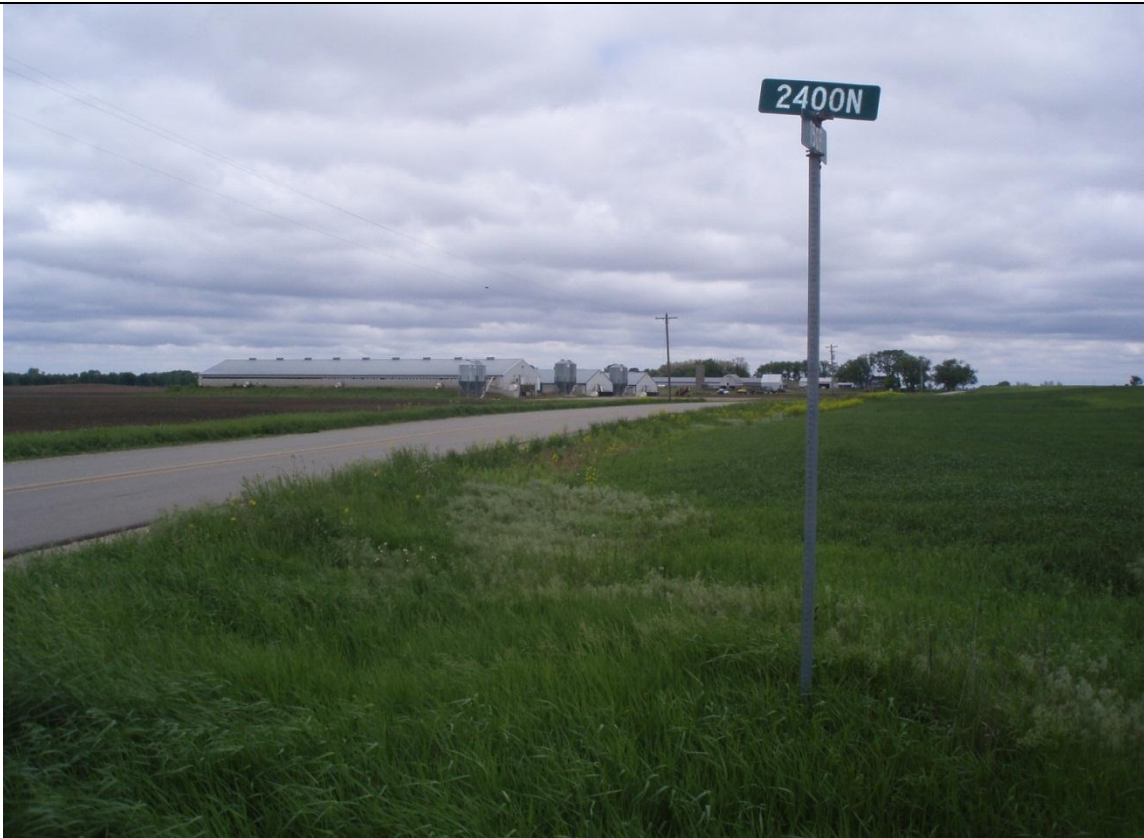
County: Bureau	
Comments: A view of the Exemption 6 and E swine facility containing three 1200-hog capacity buildings with 8 ft manure pits and natural ventilation. They are located in Section 32 of Fairfield Township, Bureau County. View is northwest.	
Photo#: 6	
Photo Title: 052313_JamesMcCune_LH(7)

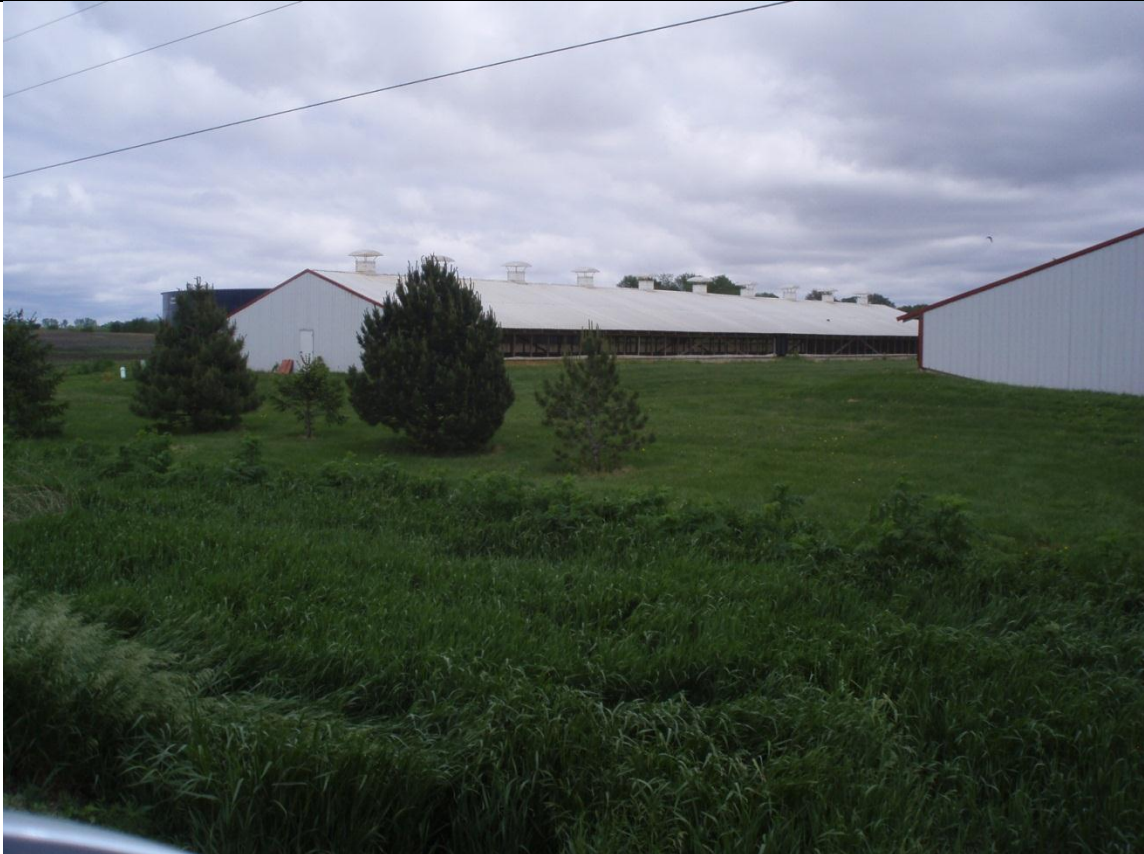
County: Bureau	
Comments: A view of the south swine facility containing three 1100-pig capacity, naturally ventilated, shallow manure pit barns. A scraper system transfers the manure into a reception pit and into a 1.6 MG Slurrystore. An identical set of buildings are located north of these that belong to [REDACTED] These buildings are located in Section 34 of Manlius Township, Bureau County along Ill. Rt. 40. Notice the border trees designed to camouflage the swine facilities. View is northeast.	
Photo #: 9	
Photo Title: 052313_JamesMcCune_LH(11)

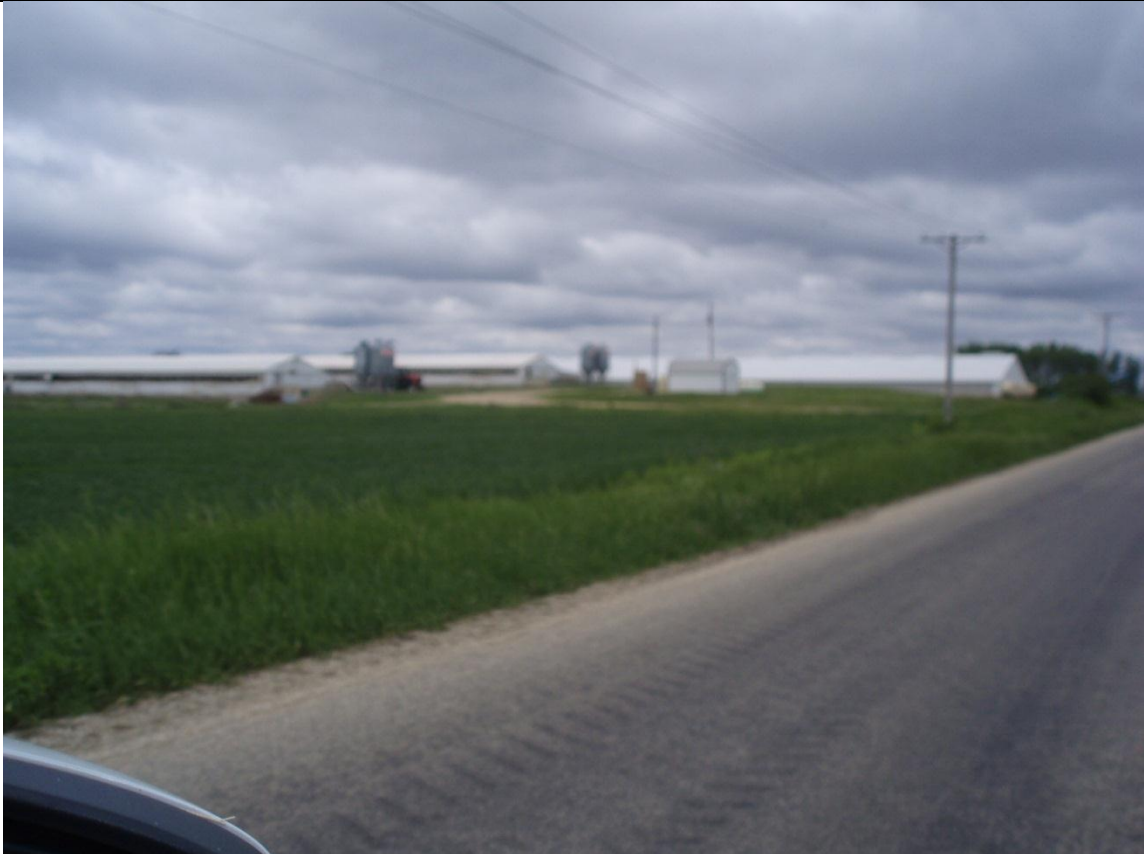
County: Bureau	
Comments: A blurry view of the Boar Power site from the south that shows the two older buildings that are due to be replaced. View is northwest.	
Photo #: 11	
Photo Title: 052313_JamesMcCune_LH(12)
